Manhole Inspection Summary

Manhole # S29I__034MH

Insp Date: **5/20/09 1:01 AM**

Location Address: **761 W Pratt St**

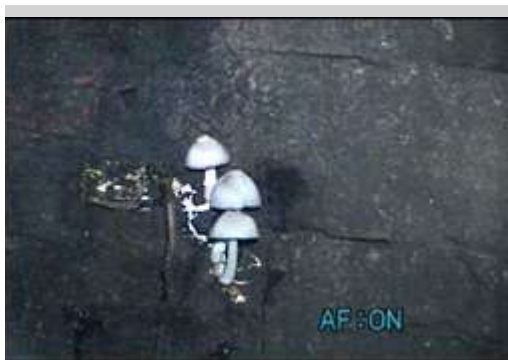
Miscellaneous

mushrooms in manhole

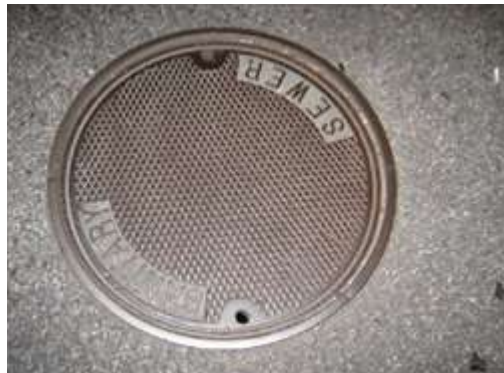
Miscellaneous

mh cover

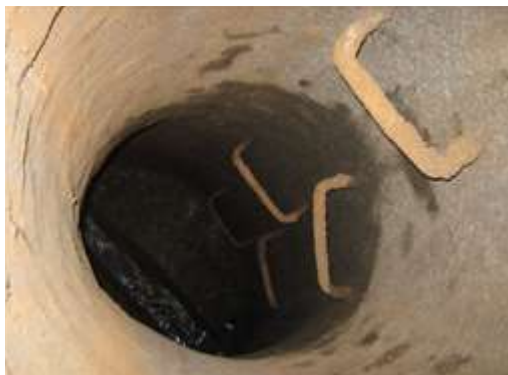
Defect 4

Infiltration: ☐ None ☐ Joint ☐ Cracks ☐ Mortar ☐ Roots ☒ **Wall**

Steps Count: **6** Missing: **0** ☒ **Corroded**

signs of infiltration on chimney walls;
corroded rungs

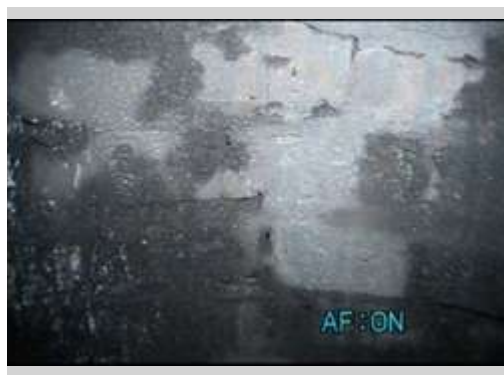
Defect 2

Infiltration: ☐ None ☐ Joint ☐ Cracks ☒ **Mortar** ☐ Roots ☒ **Wall**

infiltration from corbel wall & mortar

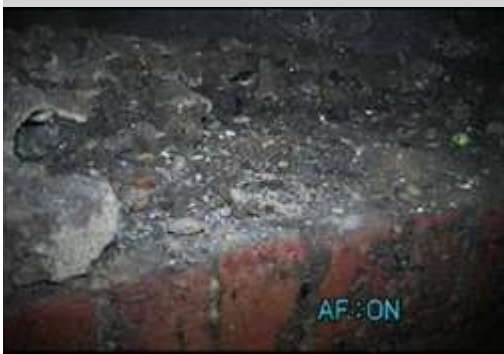
Defect 1

Condition: ☐ Sound ☐ Cracked ☐ Root Intrusion ☐ Deteriorated ☐ Leaks ☒ **Debris**

debris on bench

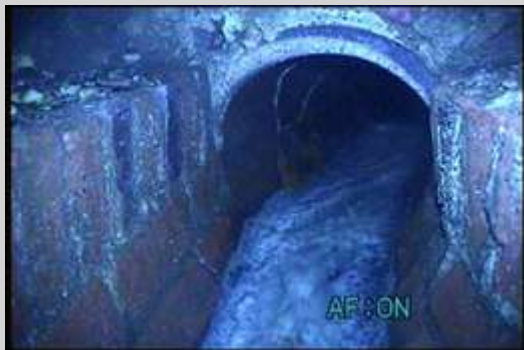
12 O'Clock Outflow

10 in. Circular Gravity Sewer
Pipe Out @ 12 O'Clock

Pipe Height: **10.8** (in.) Rod and Bar (Angled)
Pipe Material: **Clay** ☐ Pipe Lined
Invert Depth: **11.06** (ft.) Flow Characteristics: **Fast**
Deposits: ☒ None ☐ Mud ☐ Sludge ☐ Debris ☐ Grease
Silt Depth: **0** (in.) Deposits Extent:
Infiltration: **None** Pipe Seal Cond: **Sound**

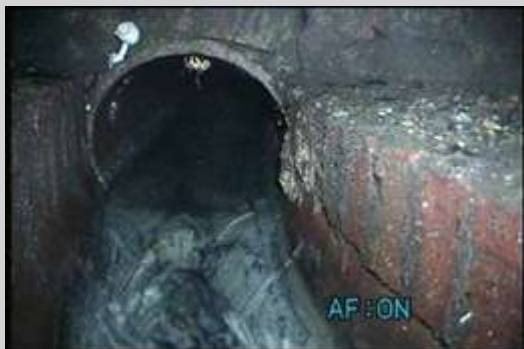
6 O'Clock Inflow

10 in. Circular Gravity Sewer
Pipe In @ 6 O'Clock

Pipe Height: **10.8** (in.) Rod and Bar (Angled)
Pipe Material: **Clay** ☐ Pipe Lined
Invert Depth: **10.90** (ft.) Flow Characteristics: **Fast**
Deposits: ☒ None ☐ Mud ☐ Sludge ☐ Debris ☐ Grease
Silt Depth: **0** (in.) Deposits Extent:
Infiltration: **None** Pipe Seal Cond: **Sound**
